MISCELLANEOUS PAPER SL-80-4

# CONCRETE AND ROCK TESTS, MAJOR REHABILITATION AND COMPLIANCE LOCKPORT LOCK, ILLINOIS WATERWAY CHICAGO DISTRICT

U. S. Army Engineer Waterways Experiment Station  
P. O. Box 631, Vicksburg, Miss. 39180

April 1980

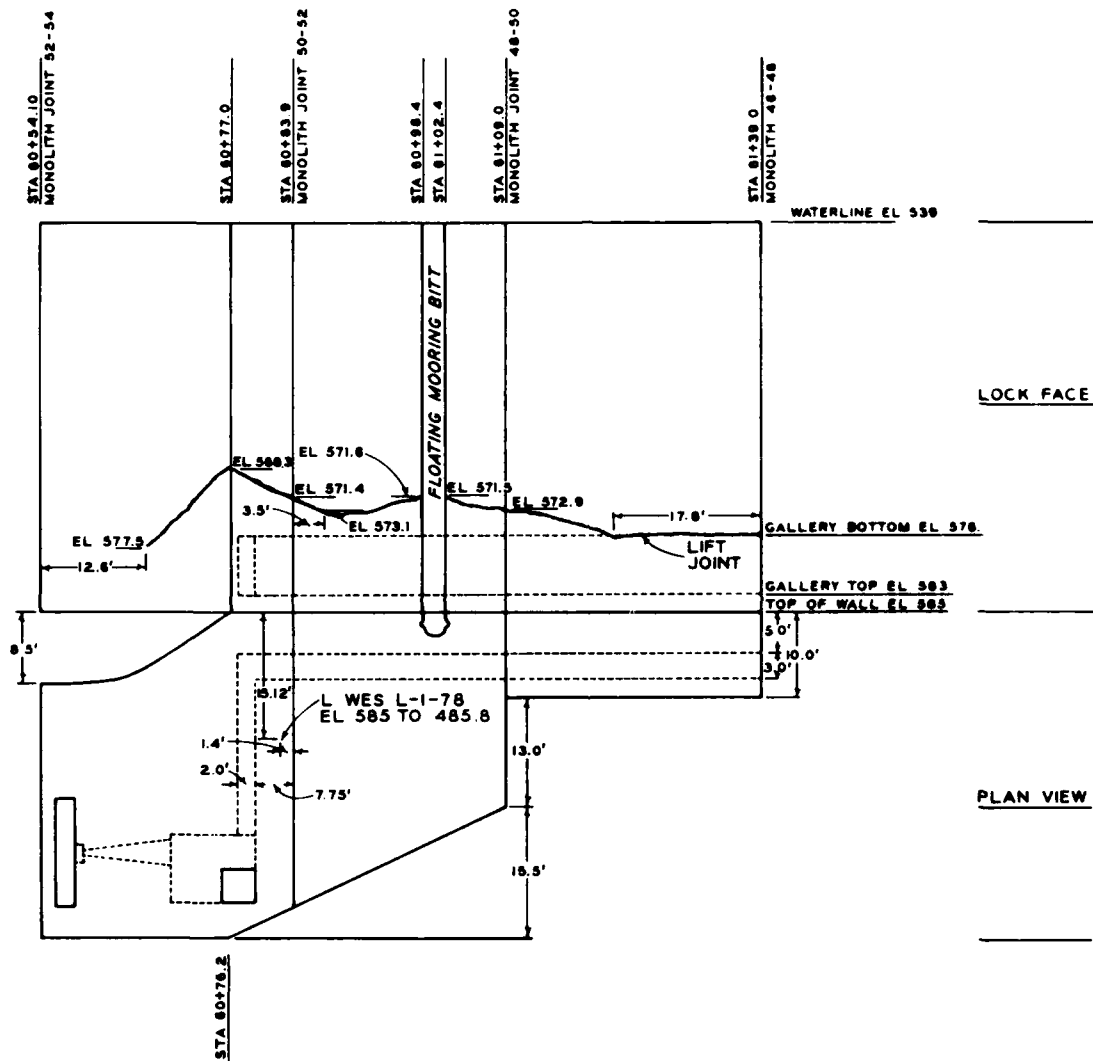
Figure 4. Results of crack survey, land wall monoliths 48, 50, and 52, Lockport Lock

42. The horizontal corner crack between the ceiling and lock side face of the cable gallery in land wall monoliths 34 through 46 continues into monoliths 48 and 50. The crack spans the entire length of monoliths

48 and 50 (an approximate distance of 55 ft) and has a maximum width of 2 mm (0.08 in.) or less. Another horizontal corner crack exists between the ceiling and the land side face of the cable gallery. It spans the entire length of the gallery that is parallel to the lock in monoliths 48, 50, and 52 (an approximate distance of 65 ft). In monolith 52 the crack crosses the ceiling landward of the corner where the gallery makes its 90° turn. The crack continues into the downstream face until it reaches the floor of the gallery. The crack then extends into the floor surface upstream for approximately 1 ft. The maximum width of the crack is greater than 12.1 mm (0.5 in.). This occurs near the land side corner where the gallery makes its 90° turn. The crack is depicted in part in Figure A22 of Appendix A. The location of the cracks noted in monoliths 48, 50, and 52 is illustrated in Figure 5. Ultrasonic velocity measurements were used in determining the possible extent of the significant cracking in monolith 52.

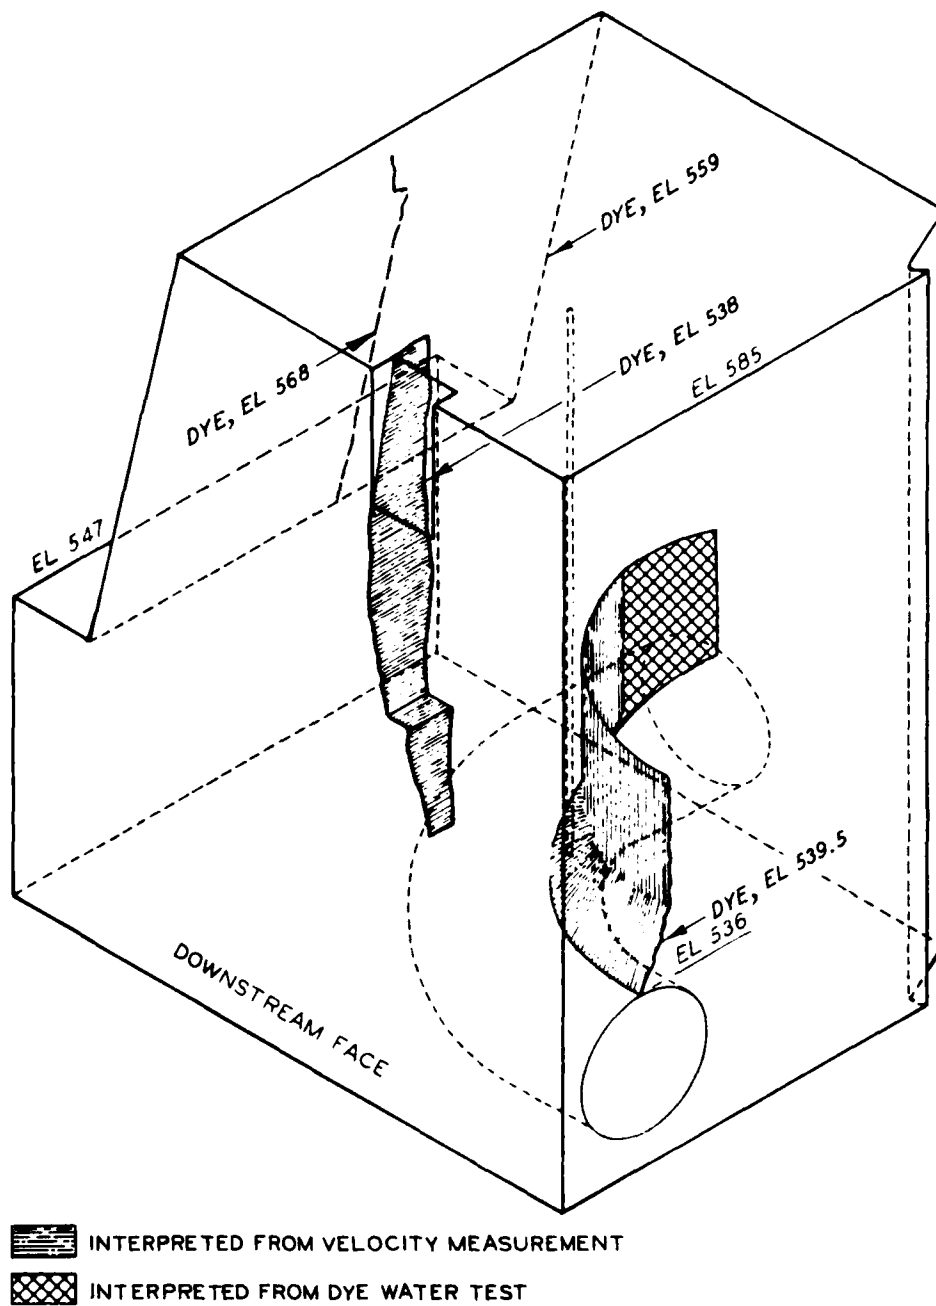
Figure 11. Probable extent of cracking into monolith 57 from the chamber side and downstream faces

53. The crack in the downstream face of monolith 57 extends at least 8 ft into the monolith near the top of the wall and 9 ft about half way down the face. The crack does not intersect boring L-2. The crack appears tight in the downstream face but was observed to be open after about 1 ft within the monolith. Its surfaces, as detected by drilling of L-31 and L-32, contained black stains and crusty white reaction products. The mechanism causing the crack is not known.

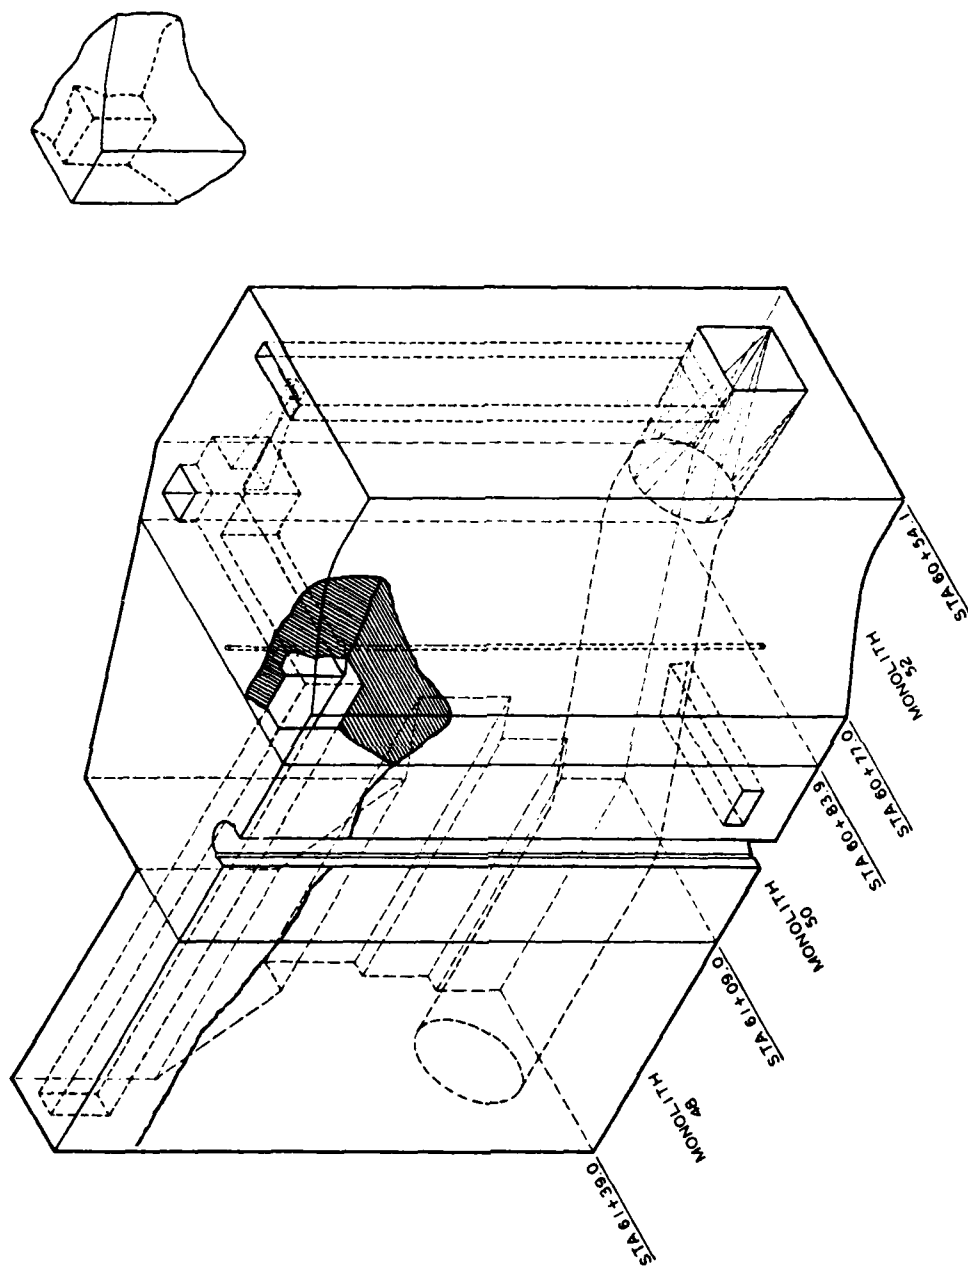
Figure 12. Interpretation of velocity data, land wall monoliths 48, 50, and 52

55. Figures 12 and 13 present graphic interpretations of structural cracks based on data obtained in the crack survey, velocity survey, and boring L-1. Figure 14 presents sections showing cracks at the corner of the cable gallery. The horizontal crack in the chamber side of the land wall is connected to the floor corner crack of the cable gallery in monoliths 48, 50, and 52. A land-side roof corner crack extends upward and is covered by a recently placed concrete overlay. In monolith 52 a wedge-shaped mass of concrete with an irregular base inclined about  $45^{\circ}$  exists with limits as shown in Figure 14. A similar wedge of concrete exists in monoliths 50 and 48, but the irregular base makes a transition from a  $45^{\circ}$  inclined base to a nearly zero incline base in monolith 48. Again the roof crack is present.

56. Structural engineers at WES were consulted concerning the significance of the structural cracks found in monoliths 48, 50, and 52 of the land wall and monoliths 51, 53, and 57 of the river wall. It was concluded that none of the structural cracks studied appear to pose any immediate problems. If an anchorage system is used at the lock during the major rehabilitation work, then adequately arranged post-tensioned tendons could be considered for monolith 57. The wedge-shaped concrete mass in monolith 52 should be tied together with post-tensioned tendons. It is believed that tendons should be installed perpendicular to the base of the wedge. Similar treatment could be used in monoliths 51 and 53 as preventative maintenance.

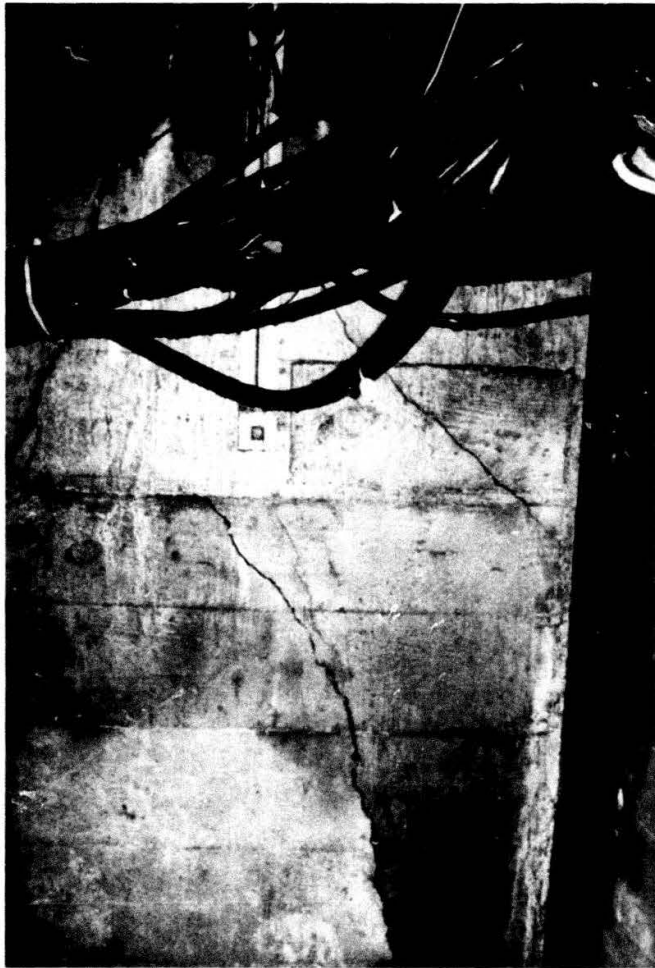
Figure A3. Upstream face at lockside turn of river wall, cable gallery, monolith 11

25. The upstream face of the cable gallery in river wall monolith 11 has several cracks near the lock side corner where the gallery makes a 90° turn. These cracks are shown in Figure A3 of Appendix A. The cracks are 2 mm (0.08 in.) or less in width and extend from within the ceiling of the gallery to the floor. This type of cracking is typical for many older lock structures where the pipe gallery makes a 90° turn. At present, these cracks appear to be limited in depth and pose no significant threat to the integrity of the structure.

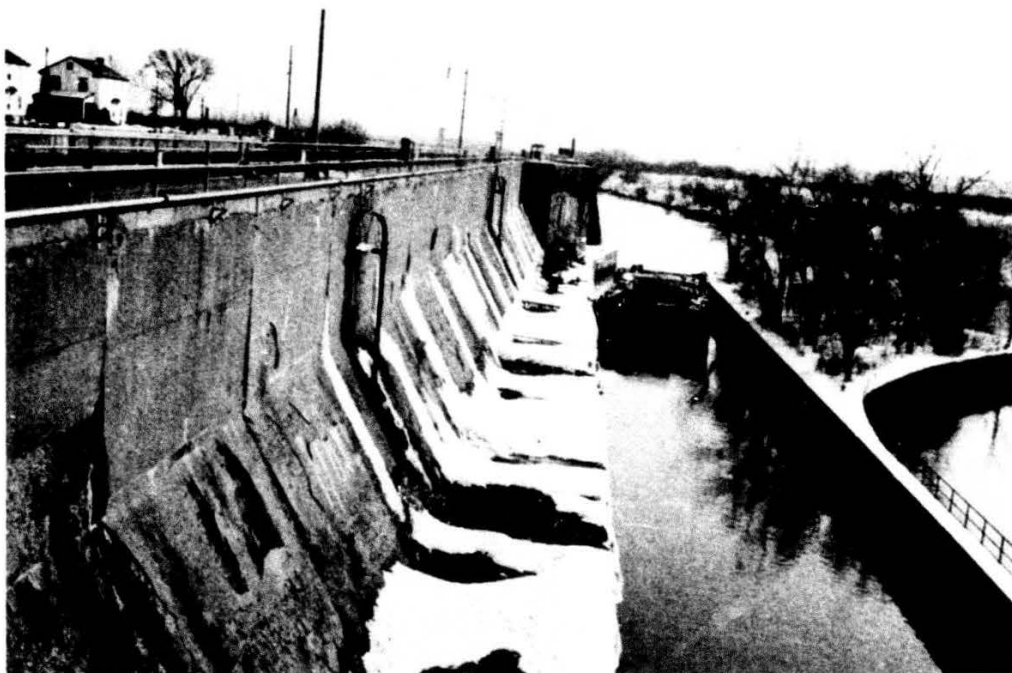
Figure A4. River face, river wall odd-numbered monoliths 17 through 49

26. In general, the exterior concrete surface of river faces of river wall monoliths 17 through 49 have severe scaling and spalling due to frost action. The most significant areas of deterioration are at the monolith joints. An overall view of the river faces of monoliths 17 through 49 is shown in Figure A4 of Appendix A. The advanced deterioration of the concrete at the monolith joints is directly attributed to water seepage. The monolith joints having the greatest amount of damaged concrete are depicted in Figures A5 through A12 of Appendix A.

29. At present, the deterioration at these monolith joints does not present a serious threat to the structural integrity of the lock. However, this could change if remedial measures are not implemented to correct the seepage problem at the joints and to protect the existing surfaces from further deterioration due to frost action.

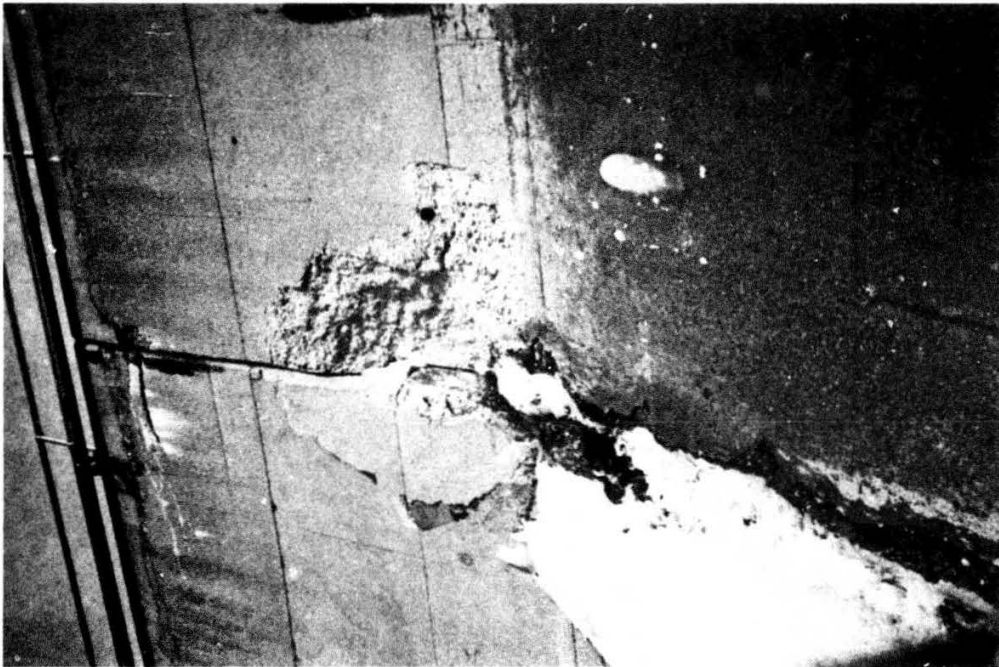
Figure All. River face, river wall mono-  
lith joint 29-31

27. From a detailed investigation it was noted that for most joints the maximum loss of concrete was less than 6 in. in depth. However, for monolith joints 29-31 (Figure A11 of Appendix A) and 37-39 (Figure A12 of Appendix A), the maximum loss of concrete was approximately 12 in. in depth.

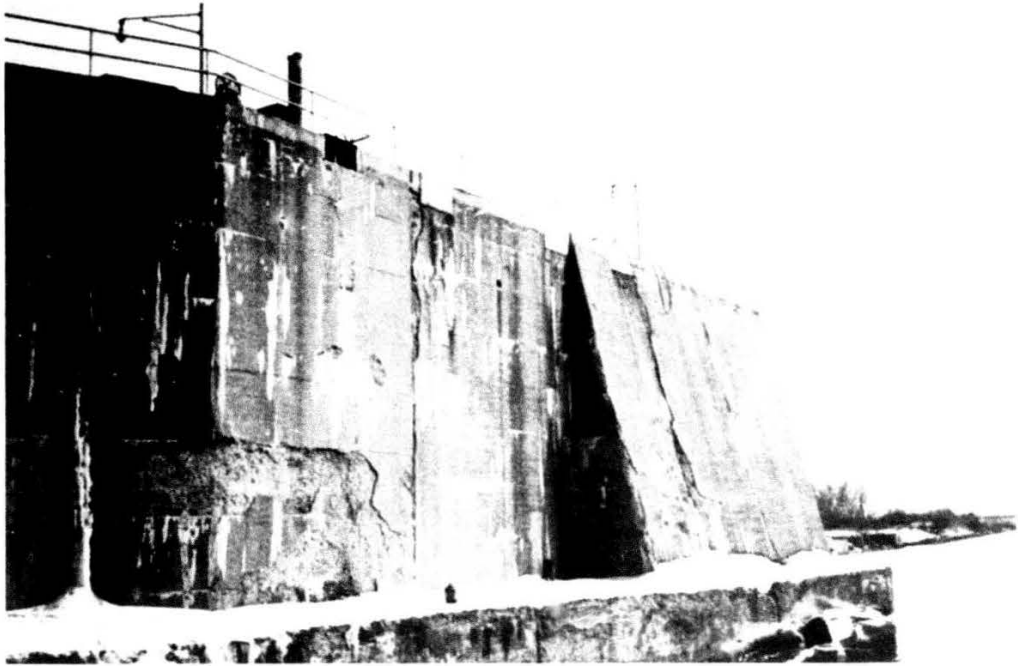
Figure A13. River face, river wall monoliths 53, 55, and 57

30. In general, the exterior concrete surfaces of the river face of river wall monoliths 51, 53, 55, and 57 also have severe scaling and spalling due to frost action. An overall view of the river faces is shown in Figure A13 of Appendix A.

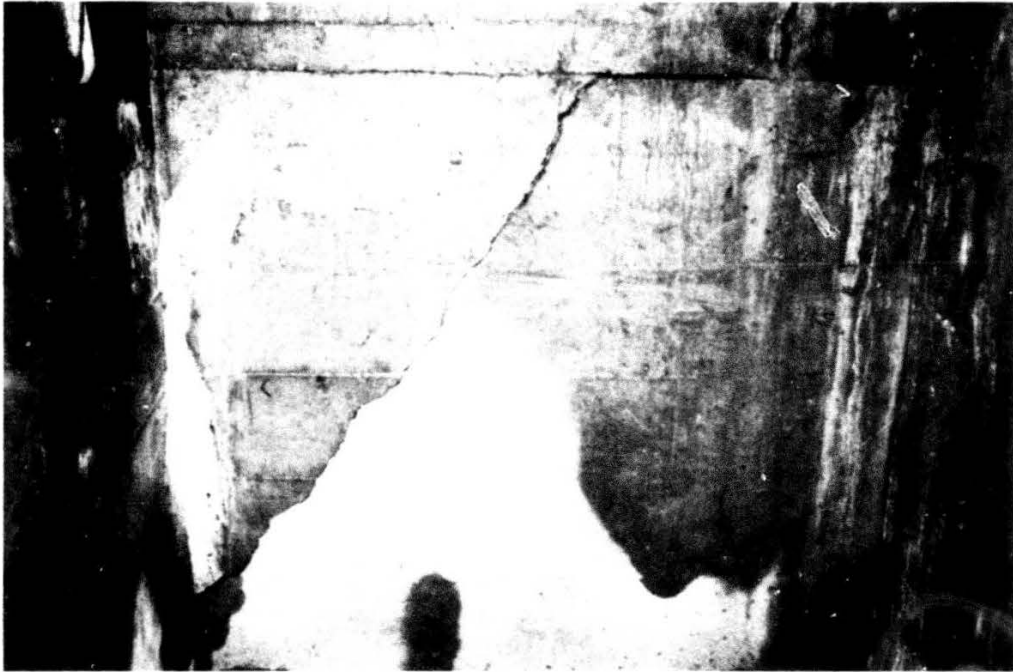
Figure A15. Downstream face, cable gallery river wall  
monolith 53

31. A horizontal corner crack between the ceiling and river side face of the cable gallery spans the entire length of the gallery in monolith 51, an approximate distance of 25 ft. The maximum width of this crack exceeds 2 mm (0.08 in.). The crack is depicted in part in Figure A14 of Appendix A. The crack continues into monolith 53 and crosses the ceiling as the gallery makes a 90° turn. The crack then extends into the downstream face until it reaches the floor at the lock side corner of the gallery. The crack in the downstream face of the gallery is shown in part in Figure A15 of Appendix A.

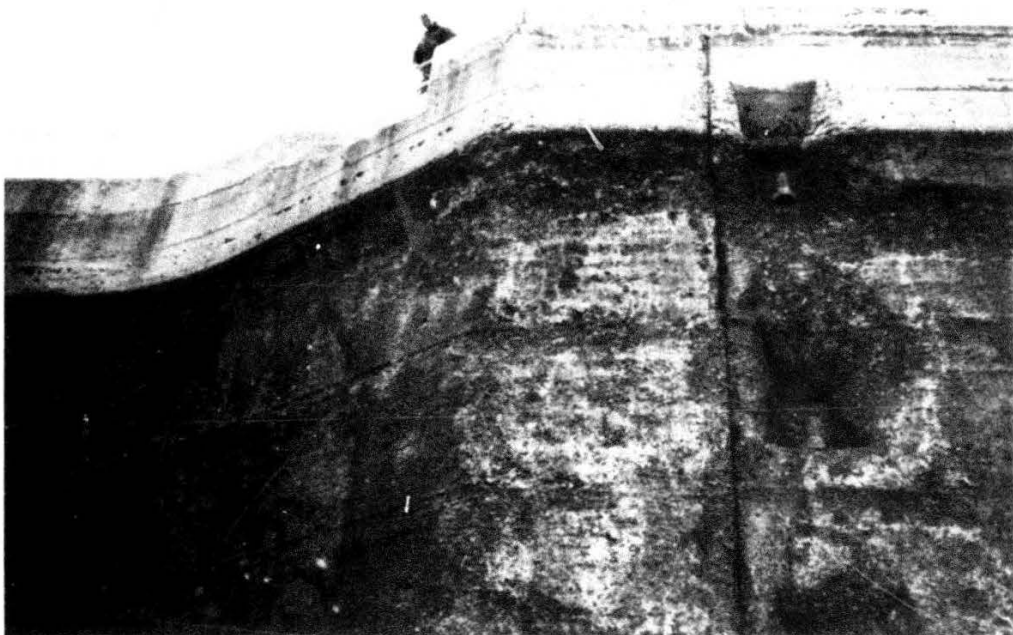
Figure A16. Lock face, river wall monoliths 51 and 53

32. The lock face was inspected to see if the crack in the gallery extended outward to the lock surface. No trace of the internal crack was observed in the lock face. The lock face of monoliths 51 and 53 in the area of concern are shown in Figure A16 of Appendix A.

33. At present, the crack in the cable gallery of monoliths 51 and 53 appears to be limited in depth and does not pose an immediate threat to the integrity of the structure. Similar cracking in the gallery of the land wall was traced to that lock wall face (monoliths 50 and 52).

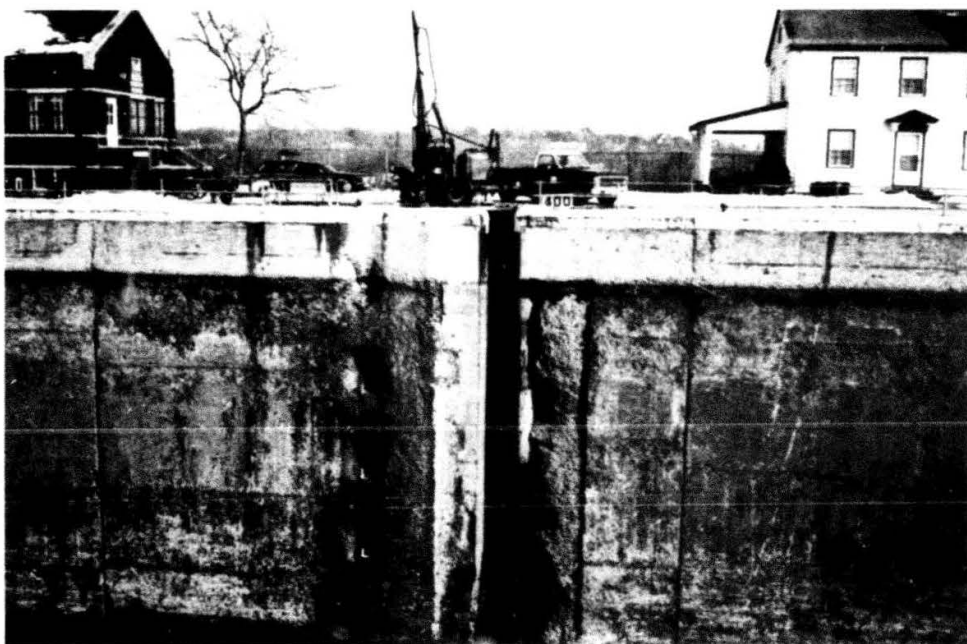
Figure A20. Lock face, land wall monoliths 34, 36, 38, and 40

37. A horizontal crack in the lock face of land wall monoliths 32 through 46 spans the entire length of these monoliths (an approximate

distance of 240 ft). The crack appears to follow a lift joint at approximately el 576. Top elevation of lock wall is 585. The maximum width of the crack is less than 2 mm (0.08 in.). The crack is depicted in part in Figure A20 of Appendix A.
